Highland
HOME INSPECTIONS, INC.

INSPECTION DATE:
Thursday, April 8, 2021

RE: Report No. 16256
708 Cliveden Rd W
Baltimore, MD
21208

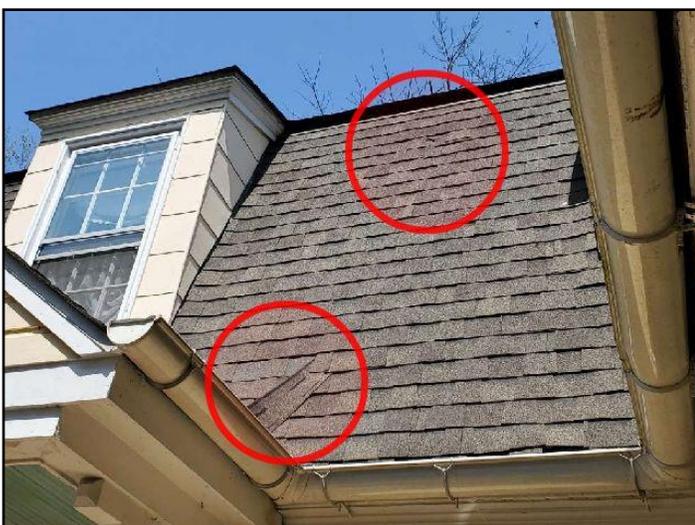
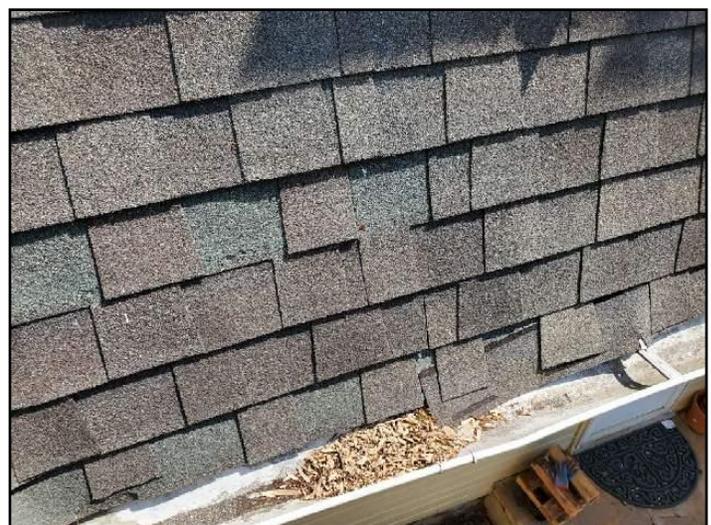
2. Condition: • Damaged or missing shingle(s) were noted.

Location: Main House Roof Rear Right Bumpout Left Slope, Rear Left Corner (Lower Roof), Rear Right Main Upper Roof

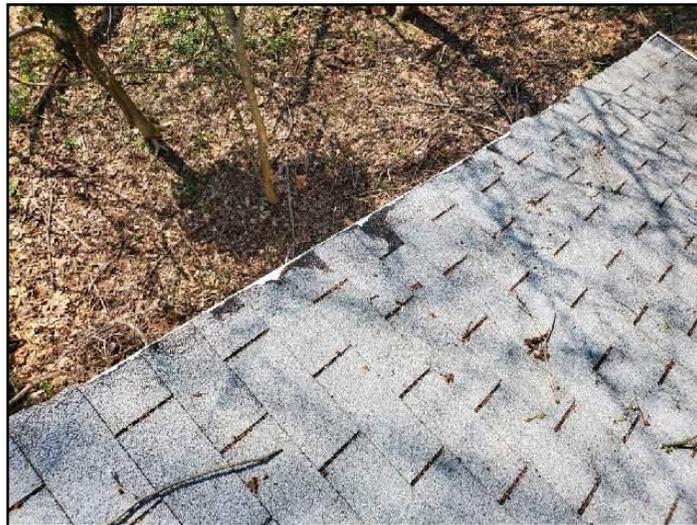
3. Condition: • Damaged or missing shingle(s) were noted.

Location: Left Rear Edge Detached Garage Roof

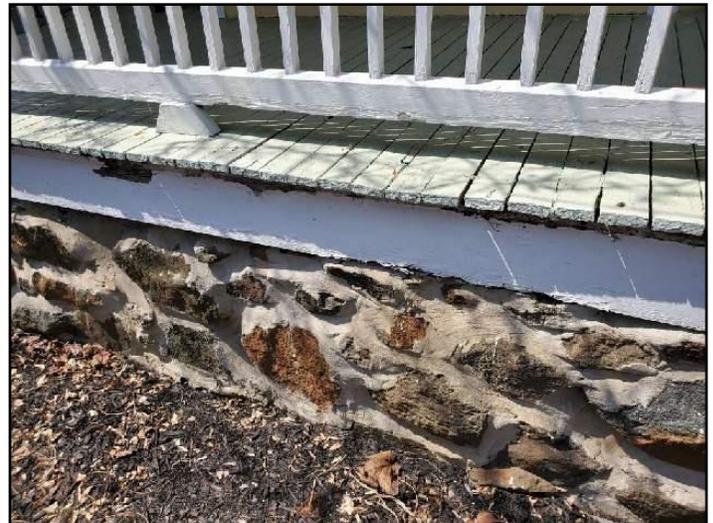
7. Condition: • Rotted wood was noted. I recommend repairing or replacing the affected areas and keeping the trim well caulked and painted to prevent further deterioration.

Task: Repair or Replace

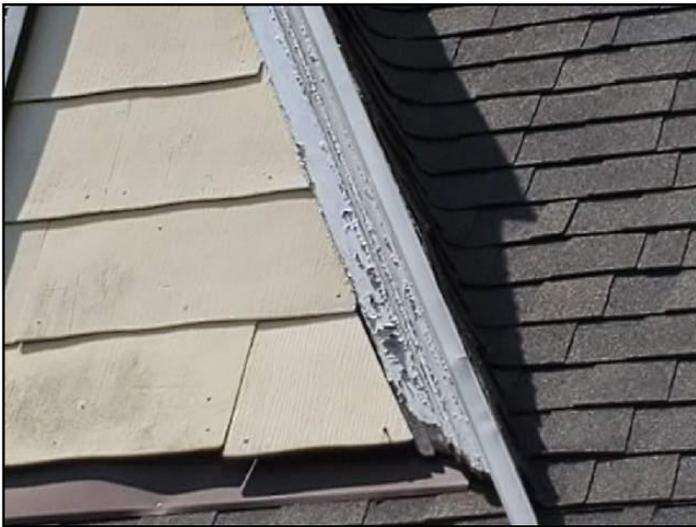
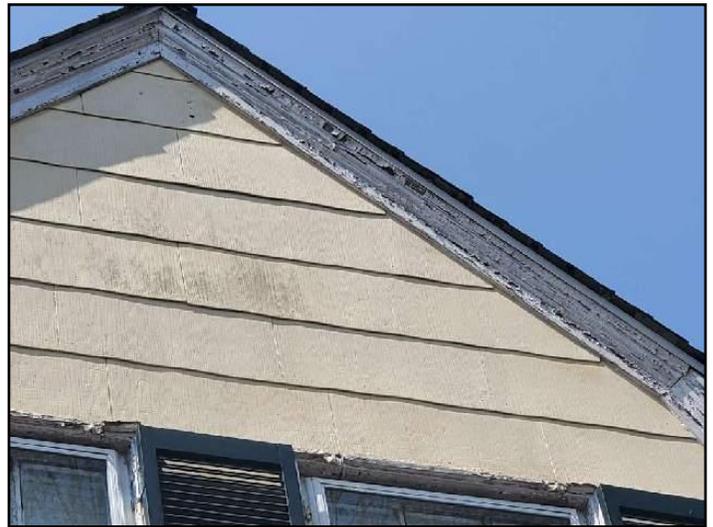
8. Condition: • The trim is in good condition (unless otherwise noted), but is in need of painting. I recommend scraping, sanding, caulking and painting the trim within the next year.

Task: Repair

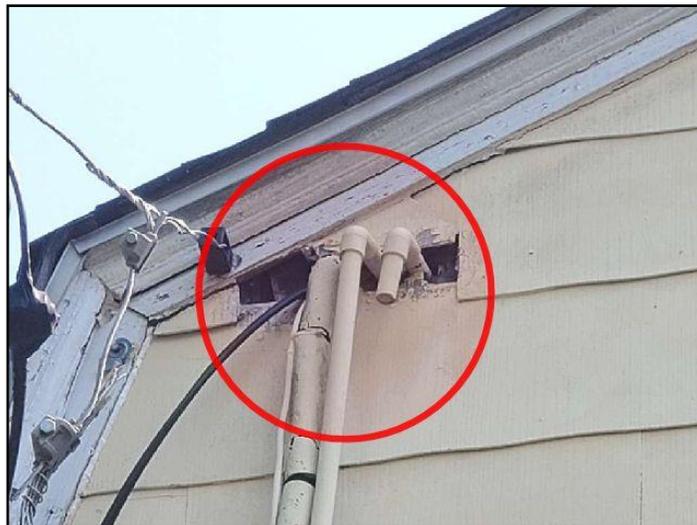
9. Condition: • All exterior penetrations should be kept well sealed to prevent vermin, air, and water infiltration. Vulnerable areas include the main electric wire, the sump pump discharge, hose bibs and cable/telephone wires.

Task: Improve

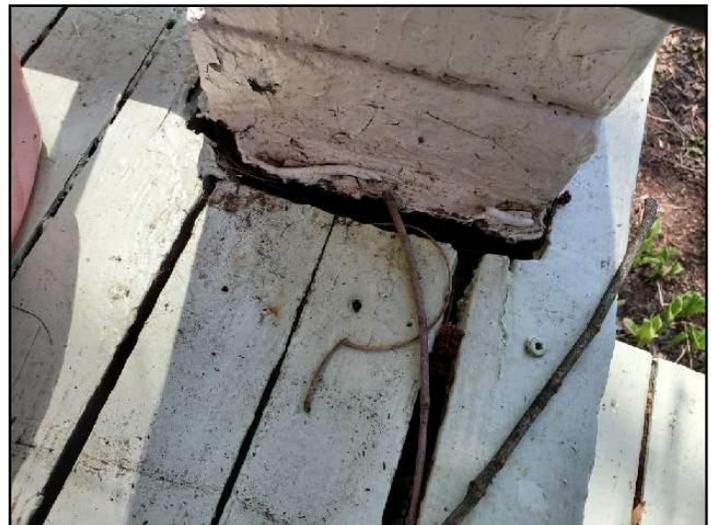
11. Condition: • Settlement and rot was noted at the front and side porch at the rear left corner, front right corner, and front center. Repair would involve the removal of the top porch boards.

Task: Repair or Replace

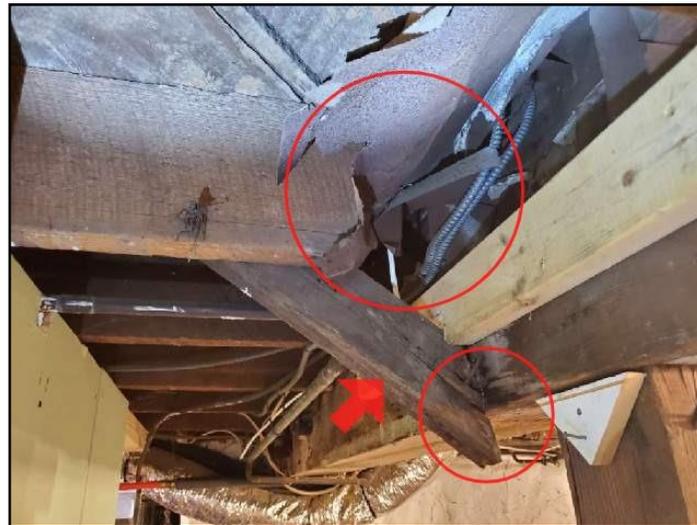
22. Condition: • A cut joist was noted at the center of the basement (front of the center beam). The repair to the joist is insufficient. The joist should be properly repaired/supported.

Location: Front Center of Basement Beam

Task: Repair

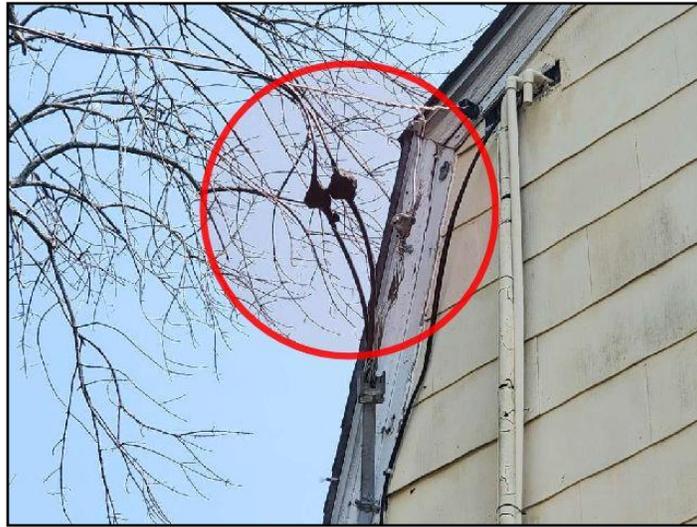
24. Condition: • The service wires (the wires bringing power to the house from the utility pole) should form a drip loop where they meet the service mast on the exterior of the home. This ensures that water will drip off the wires, rather than run into the service mast. This connection is normally the responsibility of the Utility Company, but this should be verified.

Task: Repair

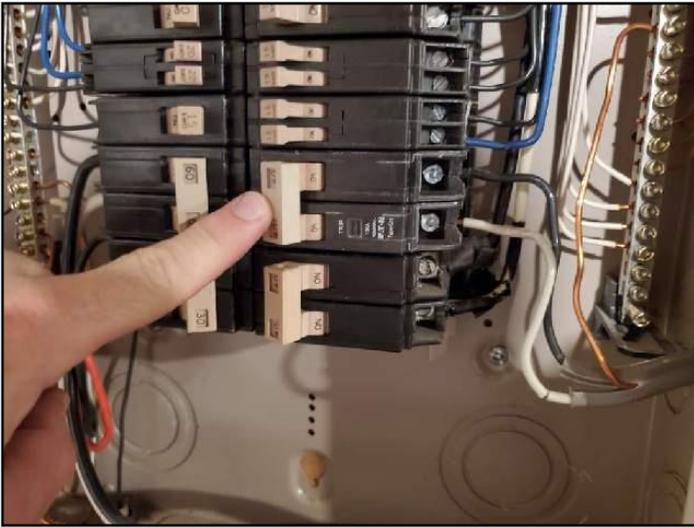
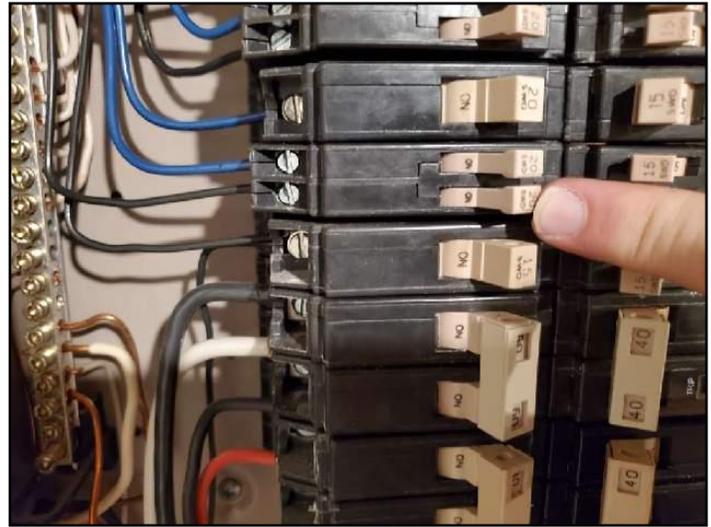
26. Condition: • A circuit breaker in the distribution panel is oversized and should be replaced. The breaker can allow too much current to flow through the wire it protects. A properly sized breaker should be installed.

Location: Breaker #26/28 (40 Amp with 10 awg Wire); Breaker #21b (20 Amp with 14 awg Wire)

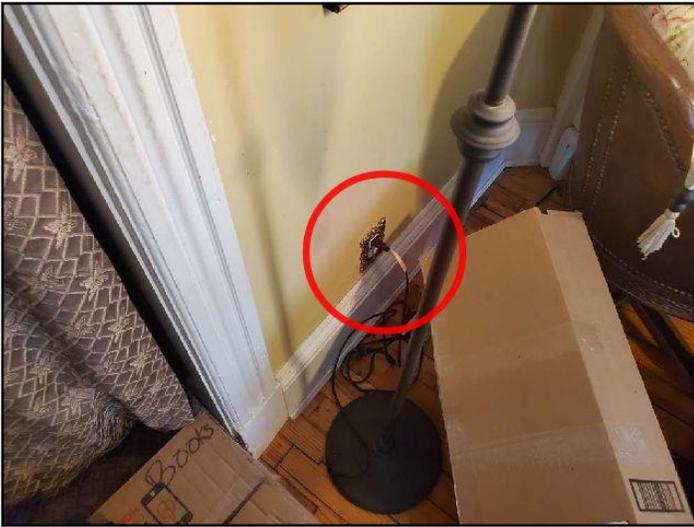
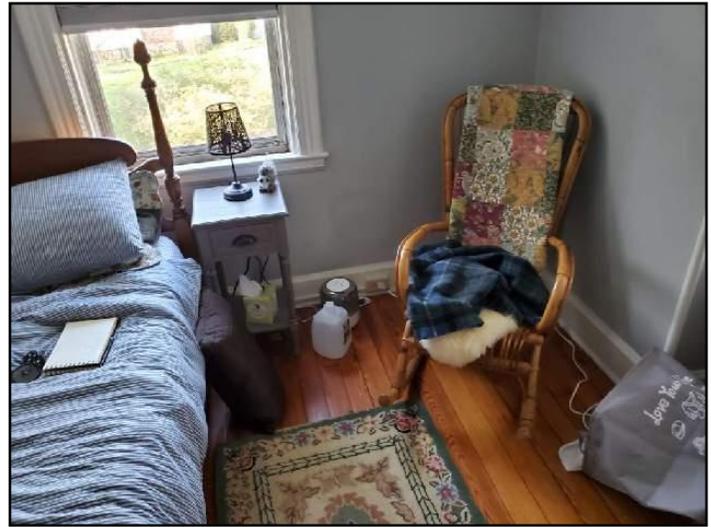
30. Condition: • Improperly wired outlet(s) (e.g. reversed polarity or ungrounded) should be investigated by a qualified electrician and repaired as necessary.

Location: Den Rear Wall, Primary Bedroom (All)

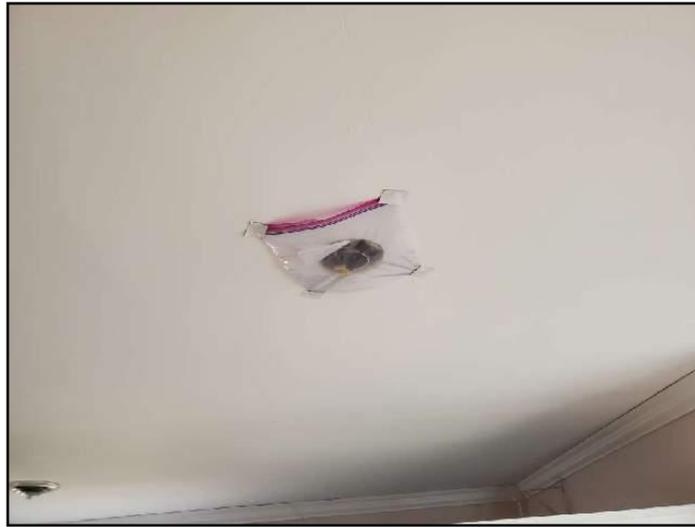
35. Condition: • The missing light should be replaced.

Task: Install

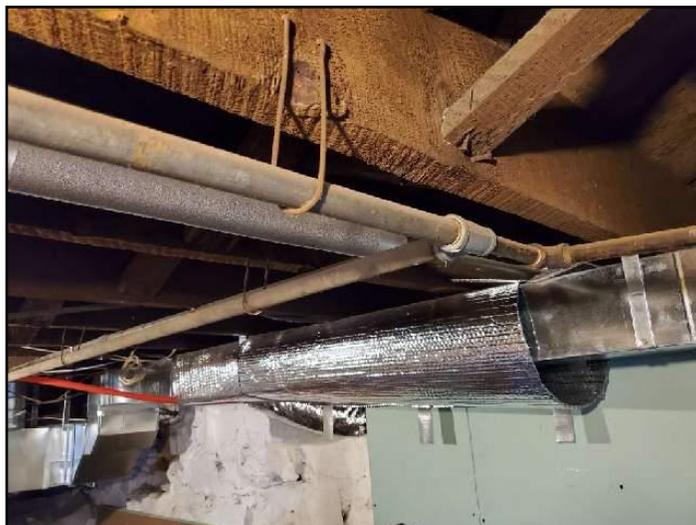
42. Condition: • [Galvanized piping was used for gas lines in some locations. Galvanized piping is not suitable for gas](#) because the zinc coating from the galvanization process can dislodge and clog gas burner orifices. Unless specified elsewhere, there was no indication of an active problem, but it would be good to replace any galvanized piping in conjunction with other plumbing work or appliance replacements.

Task: Monitor

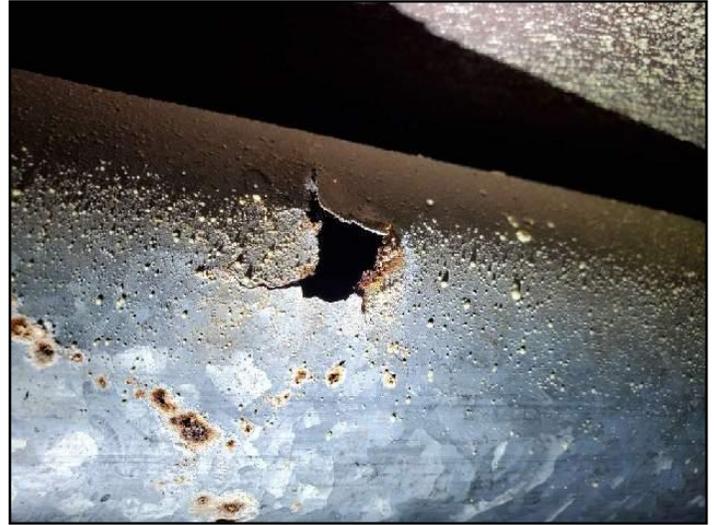
47. Condition: • The water heater vent pipe is corroded and holes were noted in the crawl space. This is a significant safety concern that should be addressed promptly.

Task: Replace

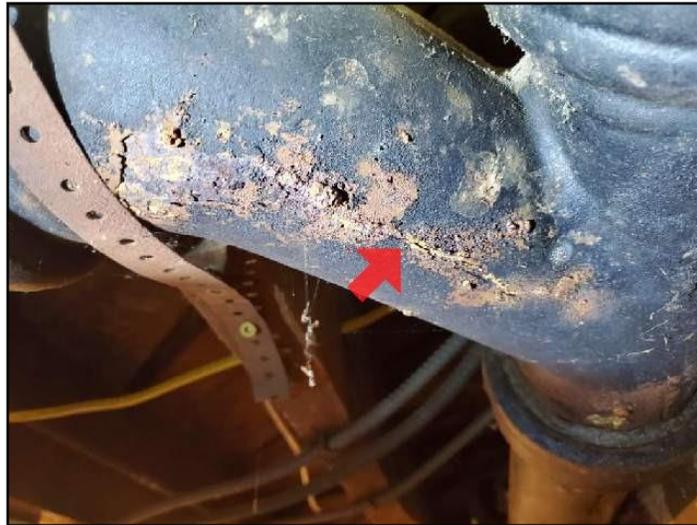
50. Condition: • The cast iron waste pipe in the center of the basement is split and should be replaced.

Location: Center Basement

Task: Replace

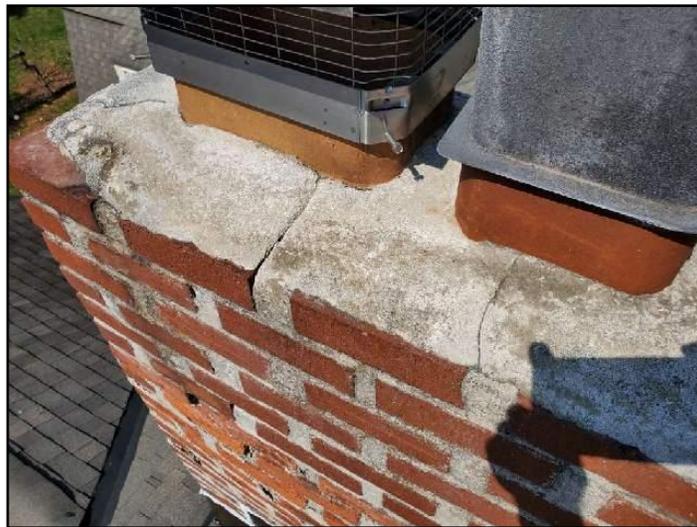
73. Condition: • The concrete crown for the masonry chimney is in poor condition and should be replaced. This the mortar on the top of the chimney that sheds water. It is worn out, cracked and broken in several places and is allowing water to enter the top of the chimney. Installation of a new concrete crown is recommended.

Task: Repair or Replace
