Highland
HOME INSPECTIONS, INC.

INSPECTION DATE:
Thursday, April 8, 2021

RE: Report No. 16256
708 Cliveden Rd W
Baltimore, MD
21208

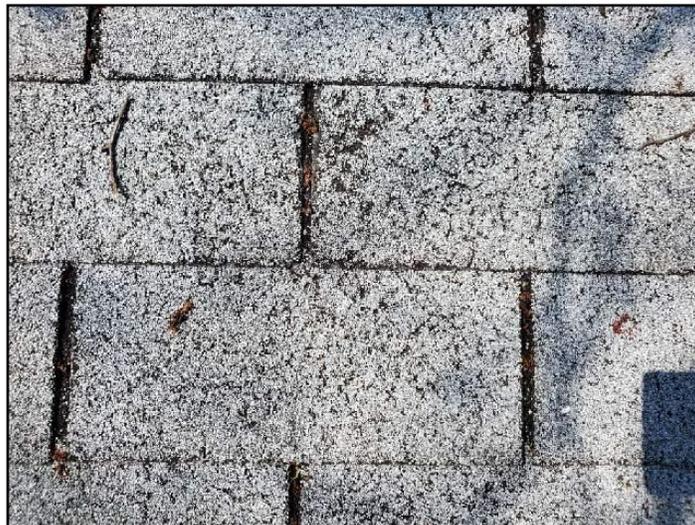
2. Condition: • Damaged or missing shingle(s) were noted.

Location: Main House Roof Rear Right Bumpout Left Slope, Rear Left Corner (Lower Roof), Rear Right Main Upper Roof

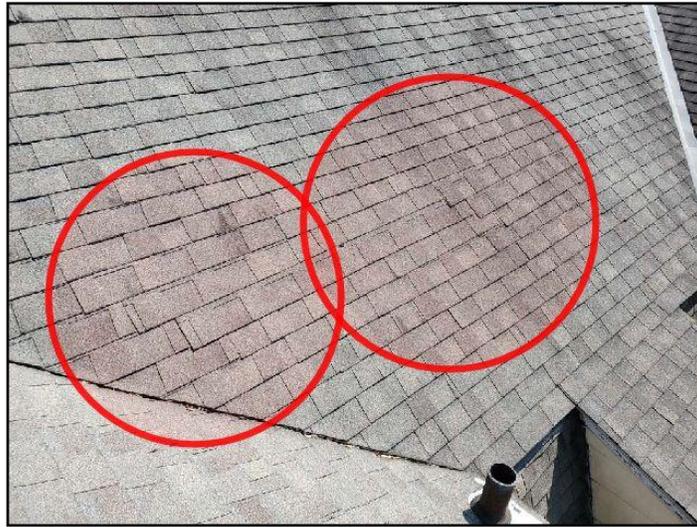
3. Condition: • Damaged or missing shingle(s) were noted.

Location: Left Rear Edge Detached Garage Roof

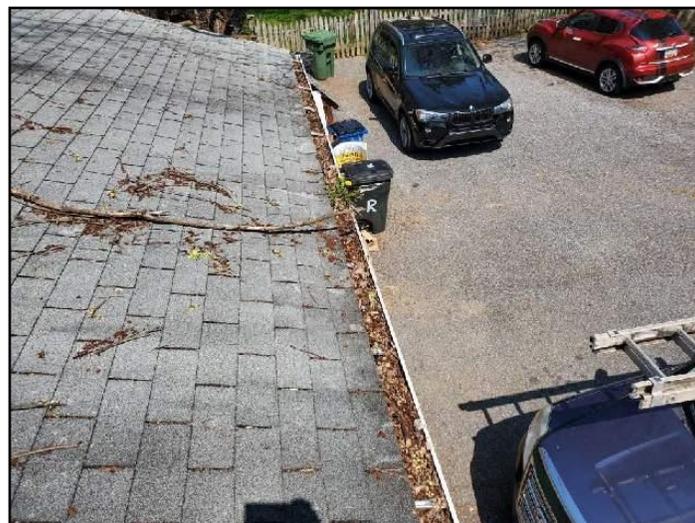
- 5. Condition:** • The gutters and downspouts require cleaning.
- Location:** Detached Garage
- Task:** Improve

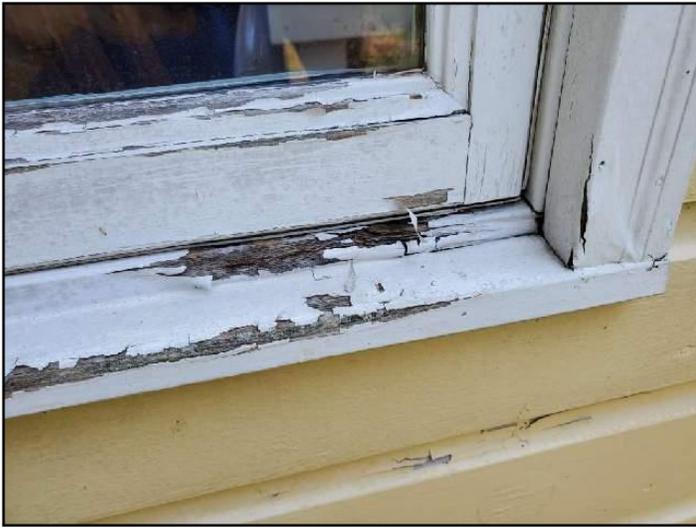
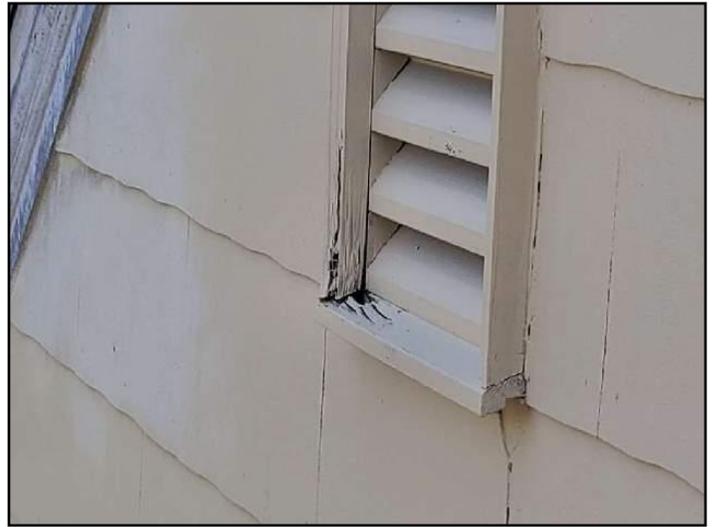
8. Condition: • The trim is in good condition (unless otherwise noted), but is in need of painting. I recommend scraping, sanding, caulking and painting the trim within the next year.

Location: Throughout

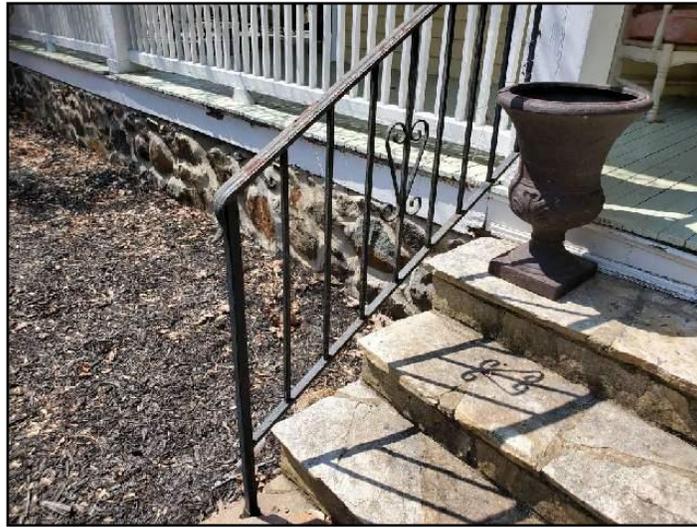
13. Condition: • Improve grading: The grading should be improved to promote the flow of storm water away from the house. This can often be accomplished by the addition or removal of soil. The ground should slope away from the house at a rate of one inch per foot for at least the first several feet. Ideally, eight (8) inches of clearance should be maintained between soil level and the bottom of exterior wall siding.

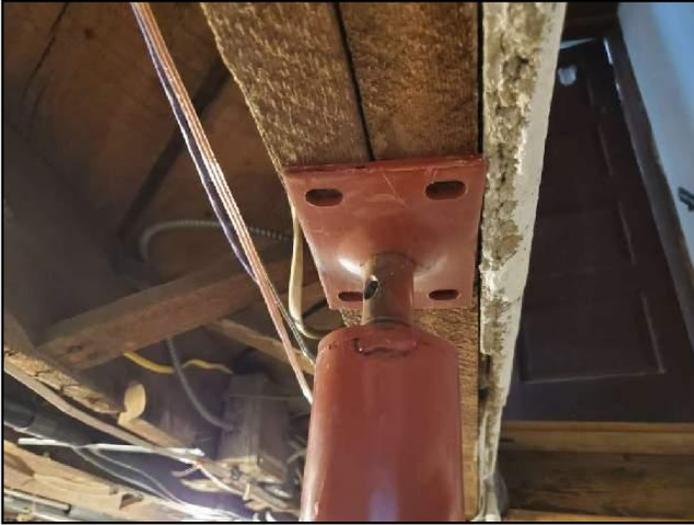
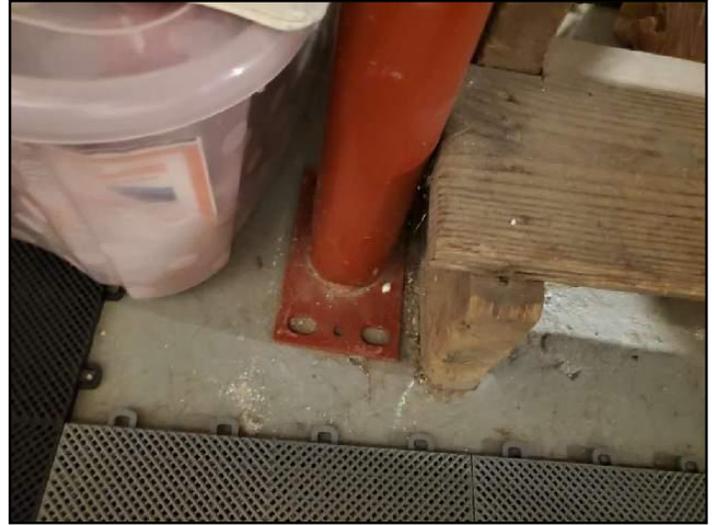
20. Condition: • [Notches or holes](#)

Location: All Beams

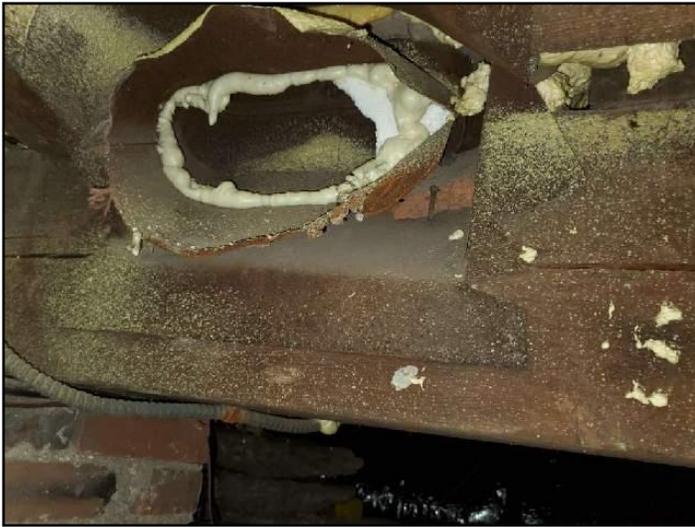
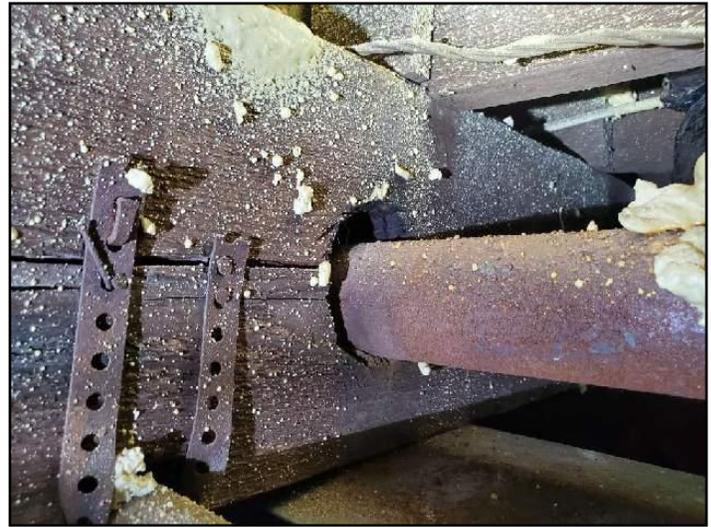
21. Condition: • A cracked floor joist was noted. Cracked joists are repaired by replacement, sistering joists along side, or additional support. I recommend having the joist(s) evaluated by a qualified carpenter and repaired.

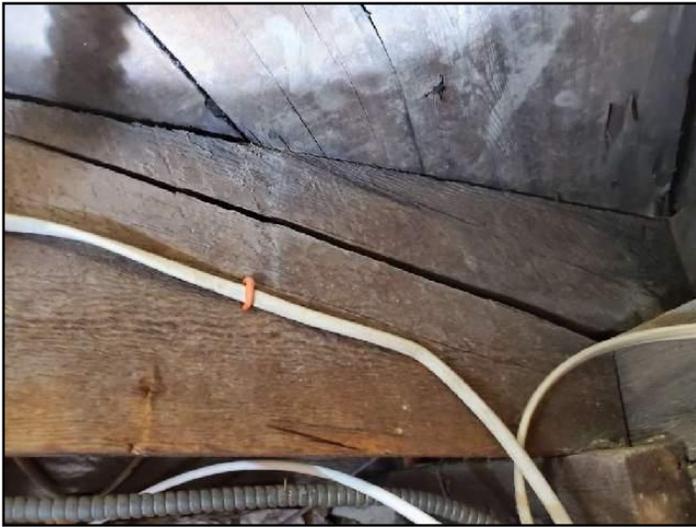
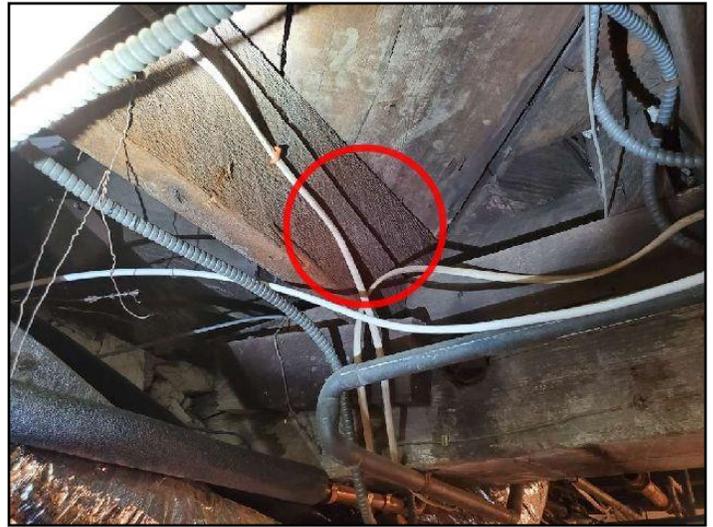
Location: Front Center of Basement Beam

22. Condition: • A cut joist was noted at the center of the basement (front of the center beam). The repair to the joist is insufficient. The joist should be properly repaired/supported.

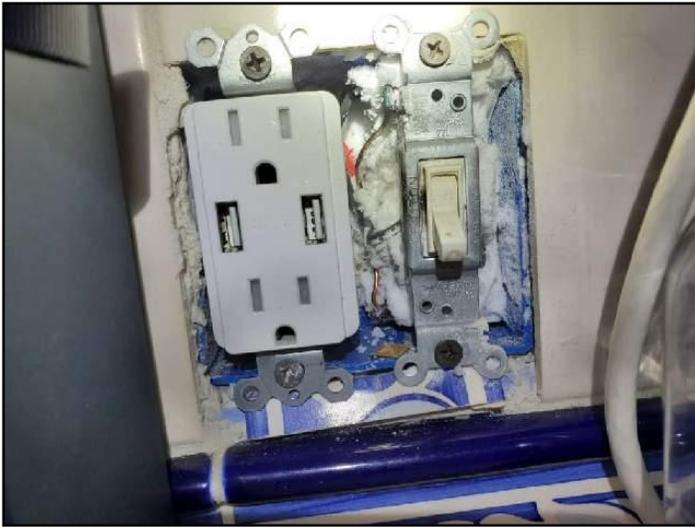
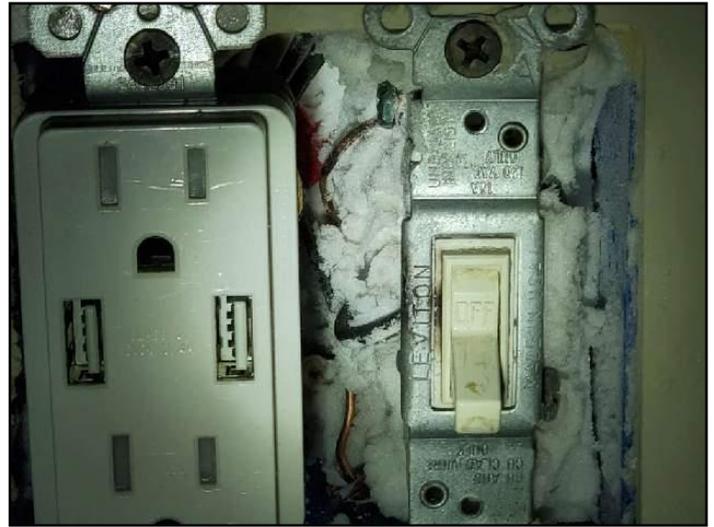
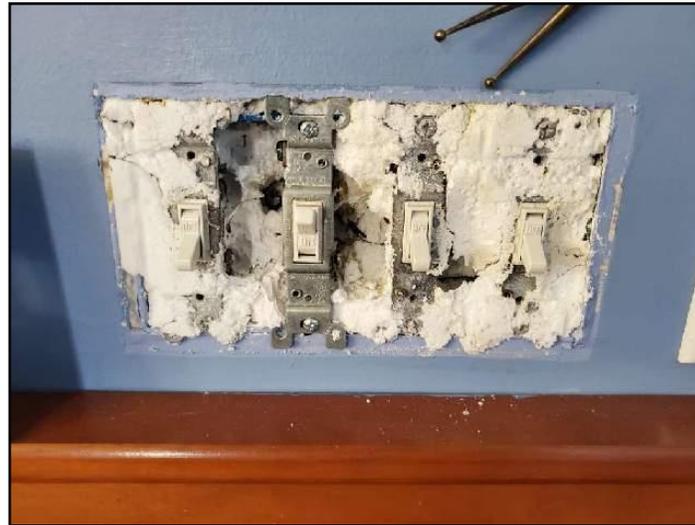
23. Condition: • Expandable spray foam was noted inside the kitchen electric boxes (outlets and switches). All of the outlet and switch boxes should be replaced.

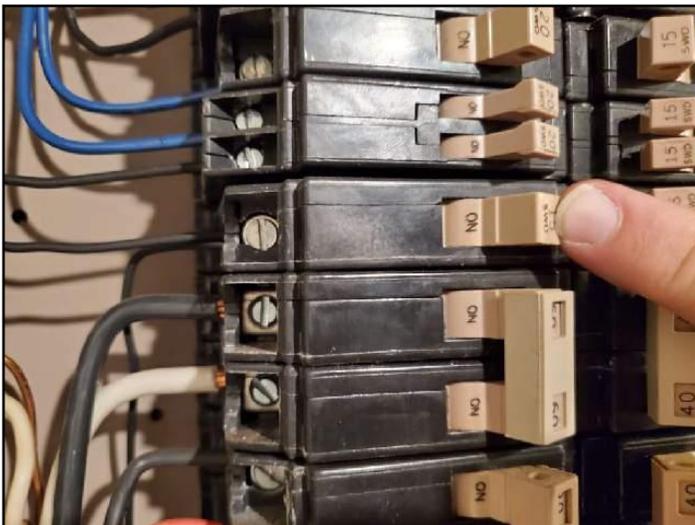
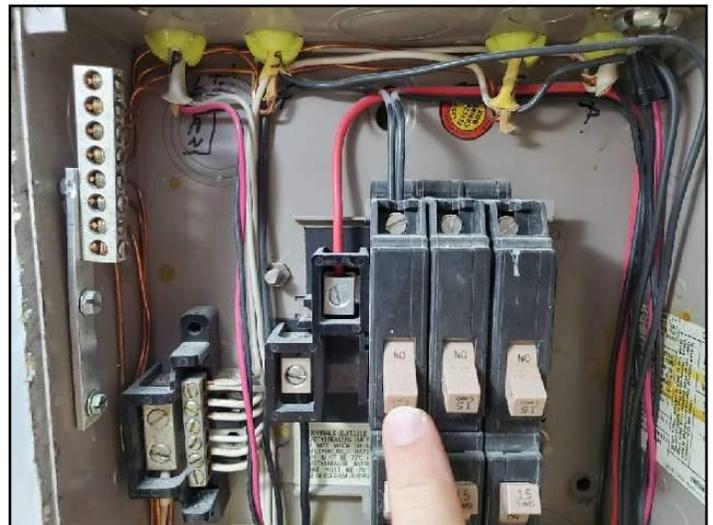
25. Condition: • Double tapped circuit breakers (a breaker with more than one wire) within a distribution panel should be corrected. Each circuit should be served by a separate breaker.

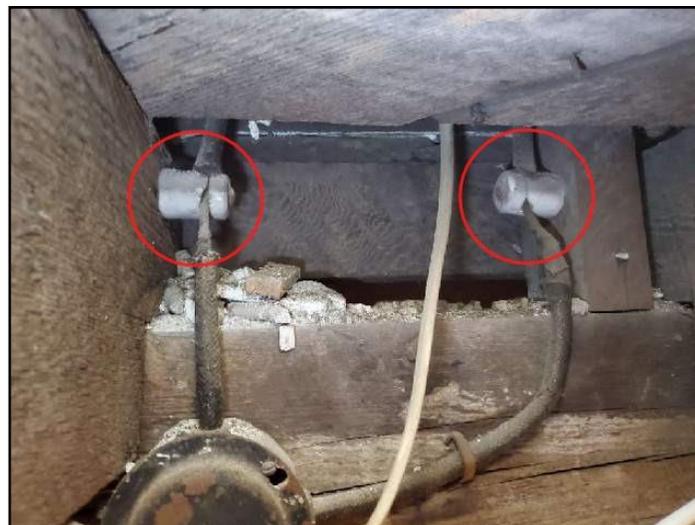
27. Condition: • Knob and tube wiring was noted in some parts of the house. Knob and tube wiring is generally considered obsolete, and in my opinion the wiring should be updated. The electric panel and some wiring may have been updated, but it should be assumed (unless it can be demonstrated otherwise) that some or all of the wiring in the walls is older knob and tube. While I did not see any immediate areas of concern, the wiring in the walls is not visible for evaluation. I recommend inquiring of the current owner about the extent of any upgrades; replacement can be a significant expense. During the course of any renovating, it is recommended that old wiring be replaced.

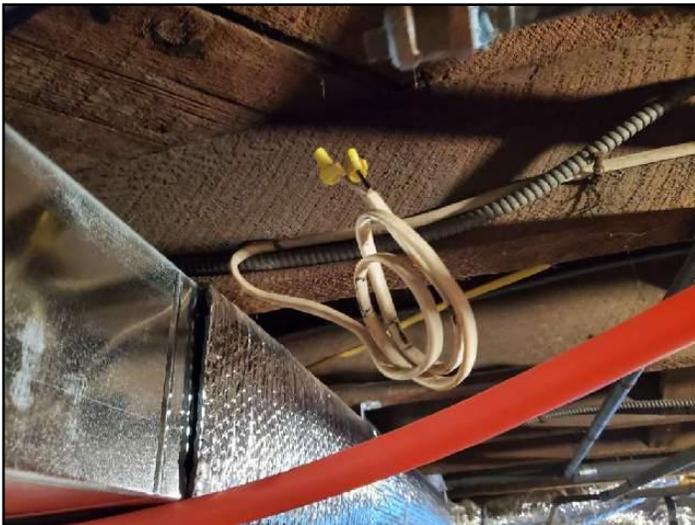
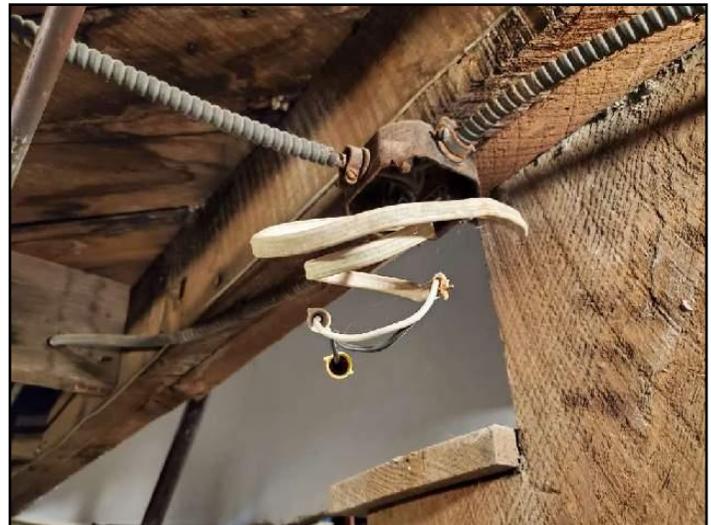
28. Condition: • Bare wire ends on hot or even abandoned wires can represent a potential shock hazard.

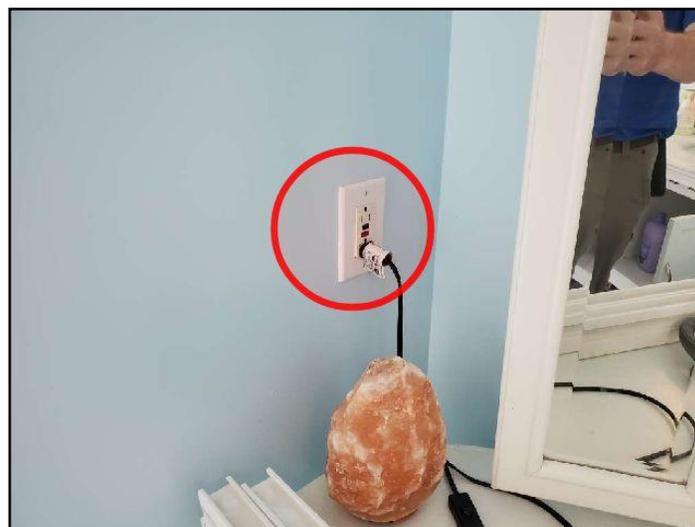
29. Condition: • A ground fault circuit interrupter (GFCI) outlet is inoperative. This outlet should be replaced.

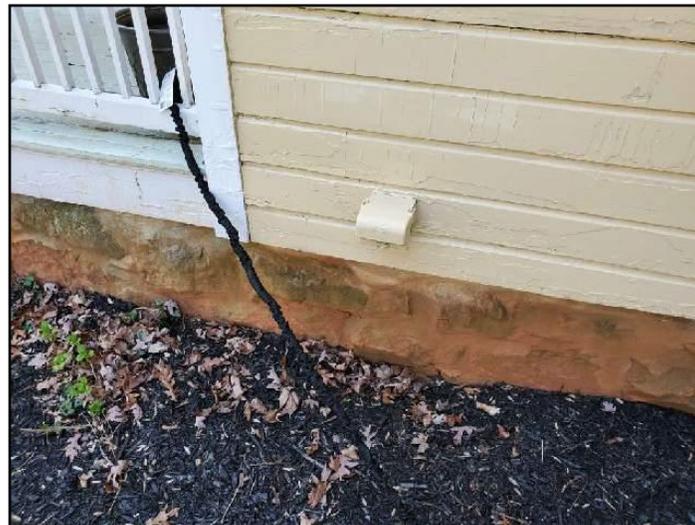
Location: Front Right Corner Exterior

31. Condition: • [An outlet is inoperative and should be repaired or replaced.](#)

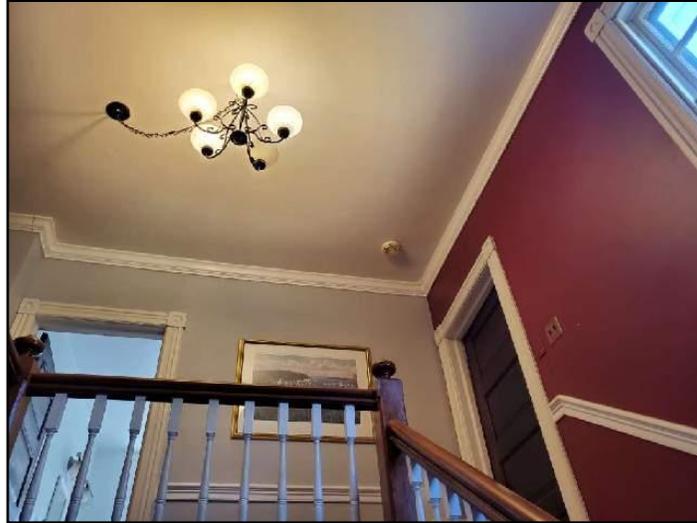
Location: Second Floor Stairway

33. Condition: • All stairways should have a switch at the top and bottom to operate the stair light. I recommend installing a light and/or switches as necessary.

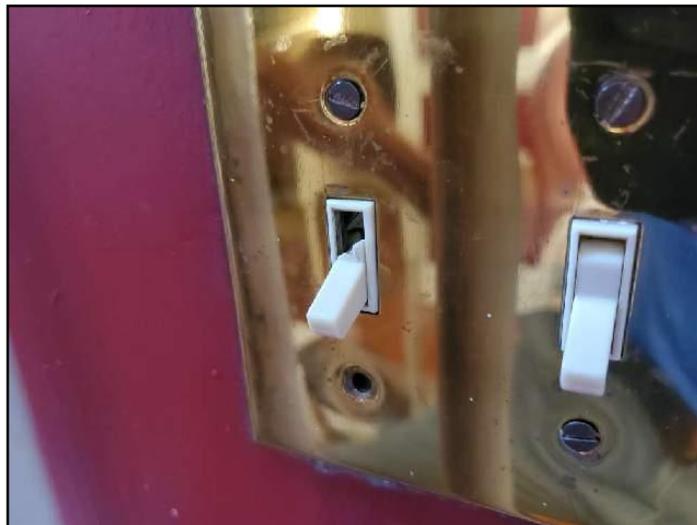
Location: Foyer (Exterior Light Switch)

34. Condition: • A switch is damaged, inoperative, or performed intermittently.

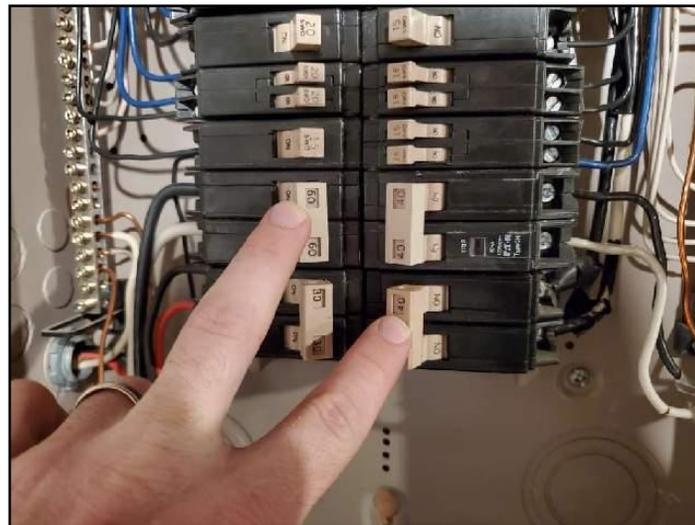
Location: Both Systems

37. Condition: • The size of the breaker protecting the outdoor unit is improper. I recommend replacing the breaker to conform to the requirements specified on the data plate. This is not a safety concern, but an improperly sized breaker or fuse will likely void the 5 year warranty on newer compressors.

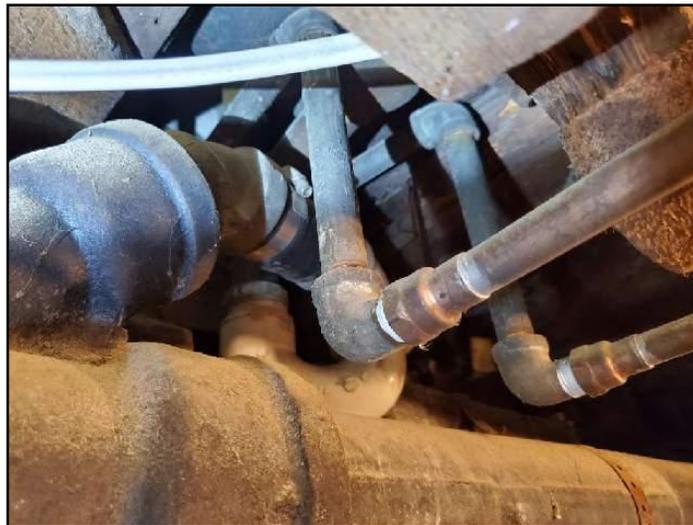
40. Condition: • The supply piping in the house is old steel piping which is subject to corrosion on the interior of the pipe. It is considered to be at the end of its expected service life. As corrosion builds up, the inside diameter of the pipe becomes constricted, resulting in a loss of water pressure. This piping is typically replaced when the loss of pressure can no longer be tolerated. I recommend replacing any exposed piping in conjunction with remodeling. The concern is based on the age of the piping and the need for eventual replacement.

rusting of galvanized pipe can greatly reduce water pressure and will eventually cause leaks as rust creates holes in the pipe walls

problems are likely to occur soonest on pipes carrying hot water, horizontal pipes and at threaded (thinner) sections

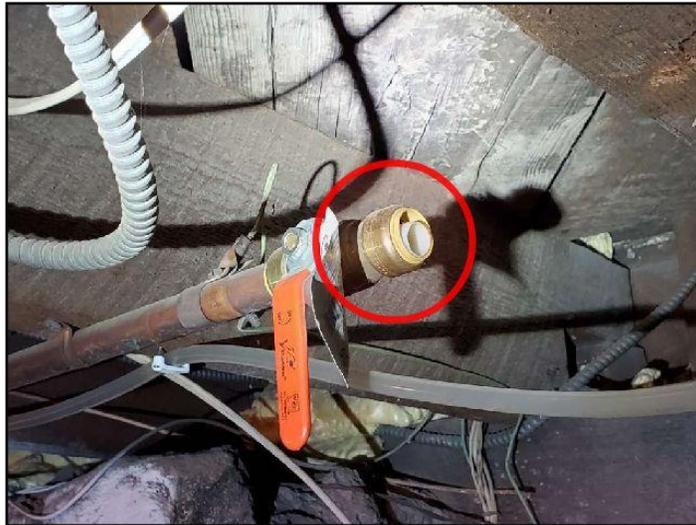
Location: Front Basement

41. Condition: • I recommend capping any open plumbing supply pipes to reduce the risk of leakage if the valve does not remain closed completely.

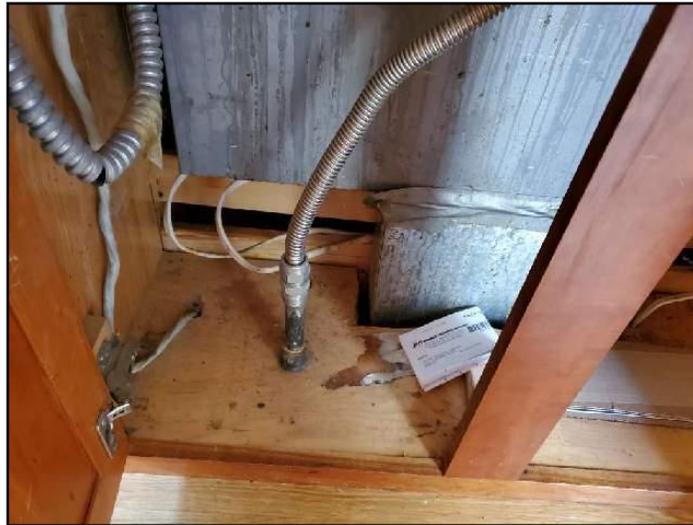
43. Condition: • No gas isolation valve was found for an appliance. If there is no isolation valve, one should be installed by a licensed plumber. If there is a valve that is hidden it should be made accessible.

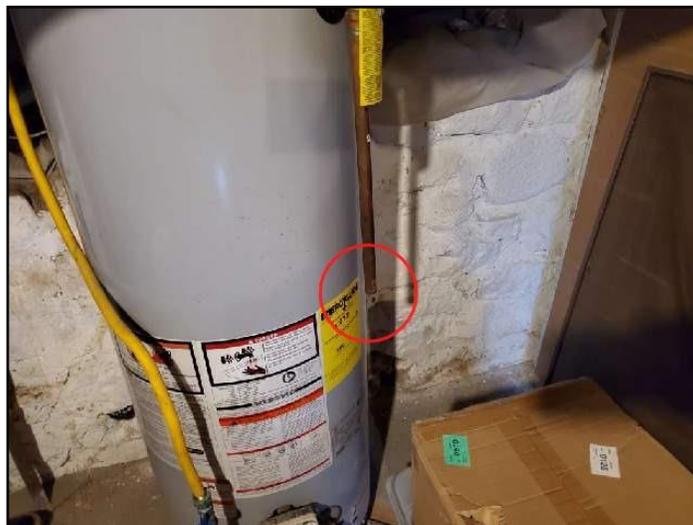
44. Condition: • The Temperature and Pressure Relief (TPR) discharge piping could be improved for increased safety. New standards require that it terminate not more than 6 inches above and not less than two times the discharge pipe diameter above the floor or the rim of a pan under the unit. The pipe should also be a properly rated material. The TPR Valve is an important safety device that must be installed in accordance with the manufacturer's installation requirements.

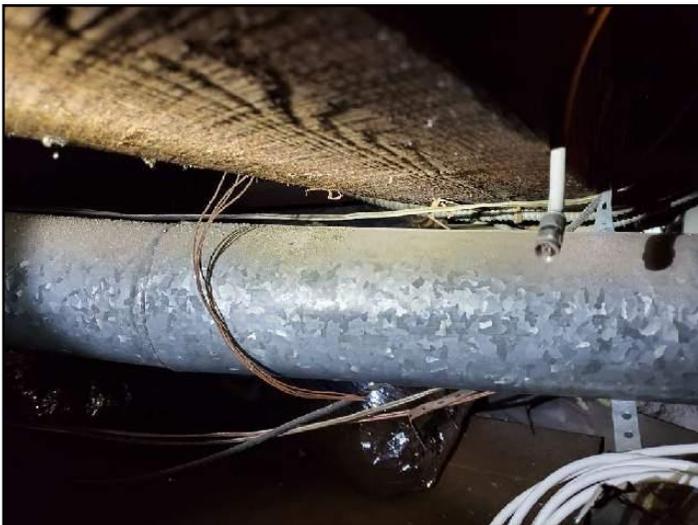
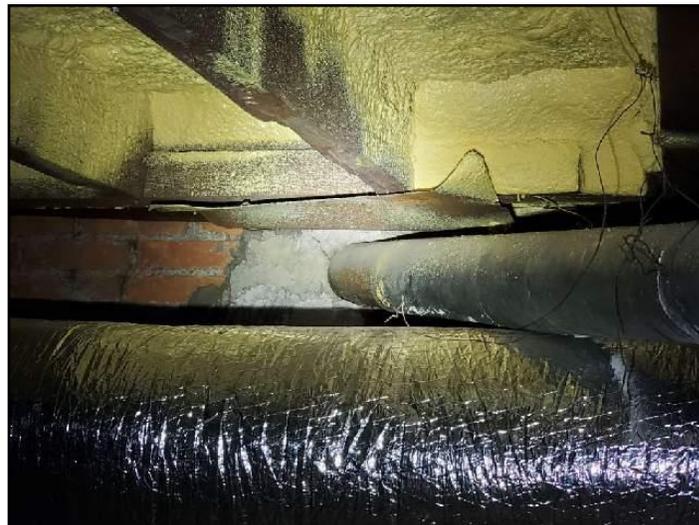
45. Condition: • The metal chimney for the water heater does not appear to be sufficiently clear from combustible materials. This condition should be repaired for fire safety. Clearance requirements vary with the material of the chimney.

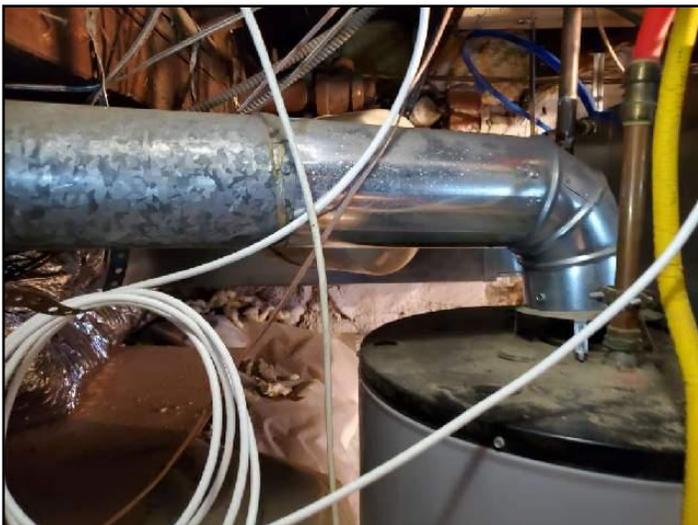
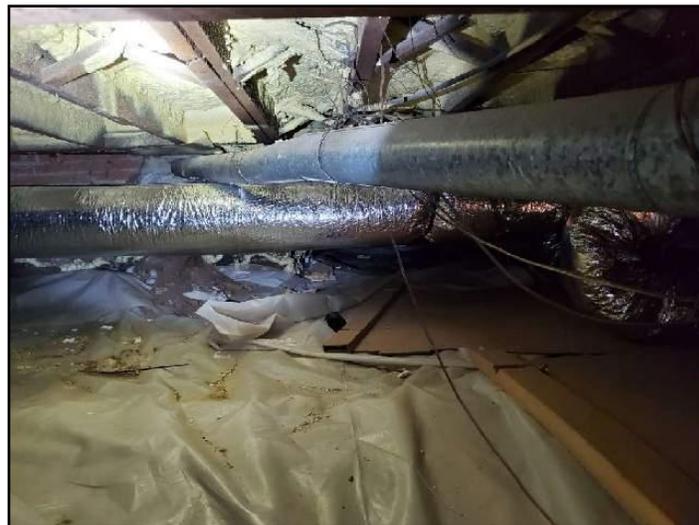
46. Condition: • Be advised that the water heater is what is referred to as orphaned. This means that the water heater alone is now using the flue up to the roof which was originally sized for both the furnace and water heater. The water heater alone, may not generate enough heat to properly discharge the combustion exhaust. If improper venting is suspected, a smaller vent would be installed inside the larger one by a chimney specialist.

The length of the vent pipe to to masonry chimney is longer than standard.

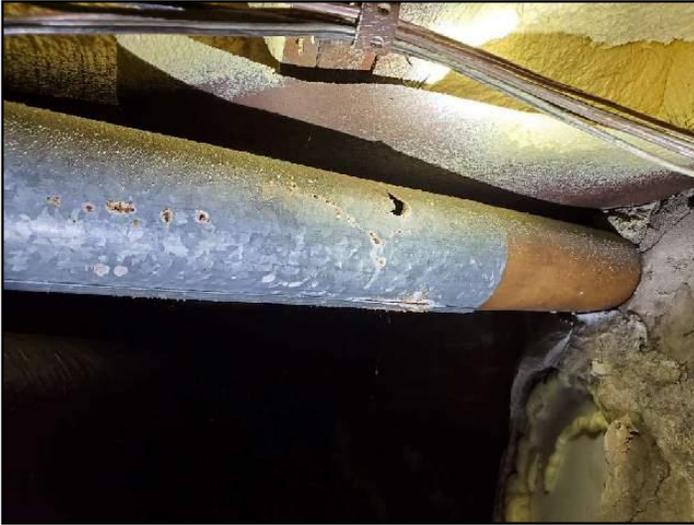
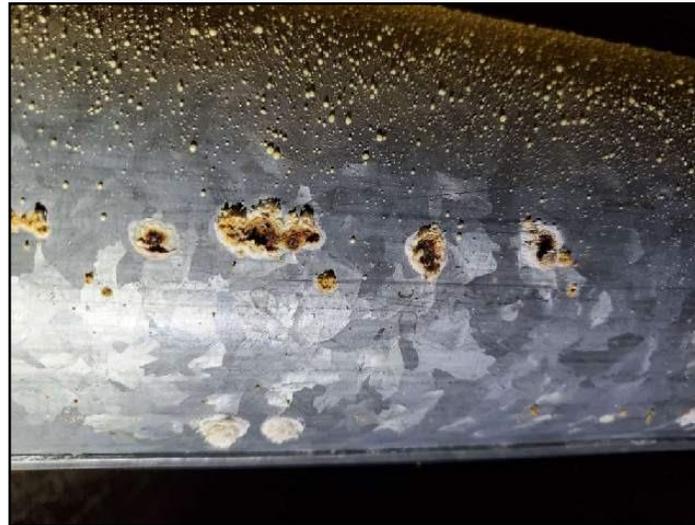
47. Condition: • The water heater vent pipe is corroded and holes were noted in the crawl space. This is a significant safety concern that should be addressed promptly.

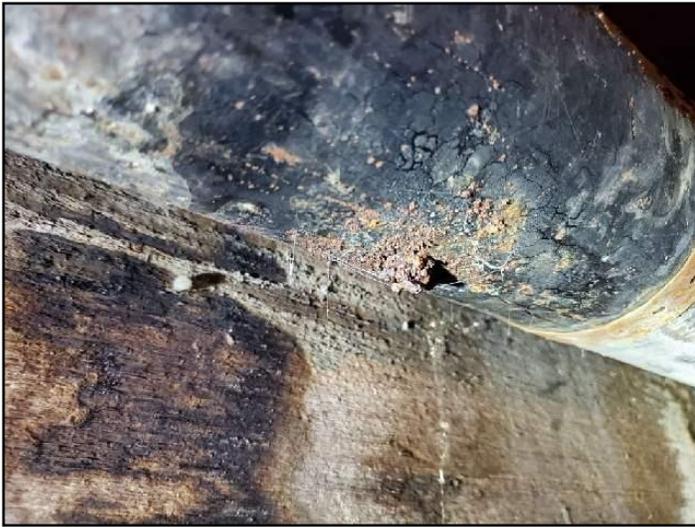
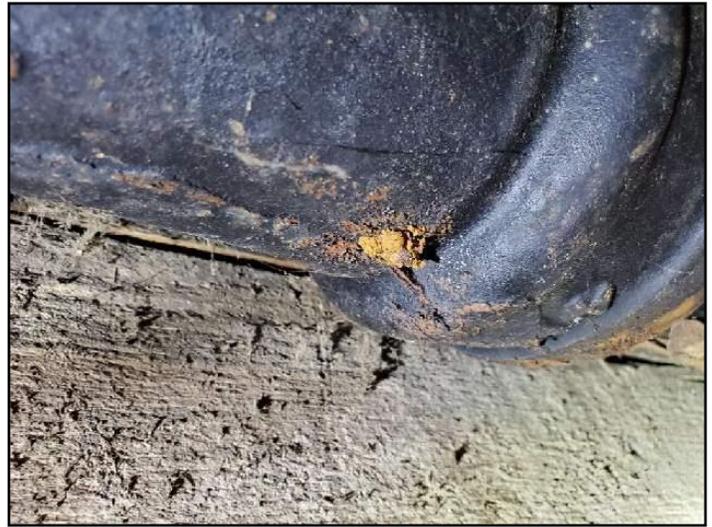
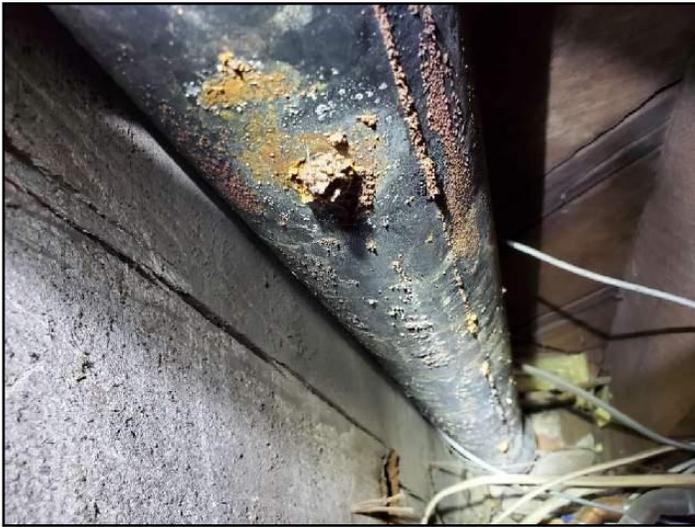
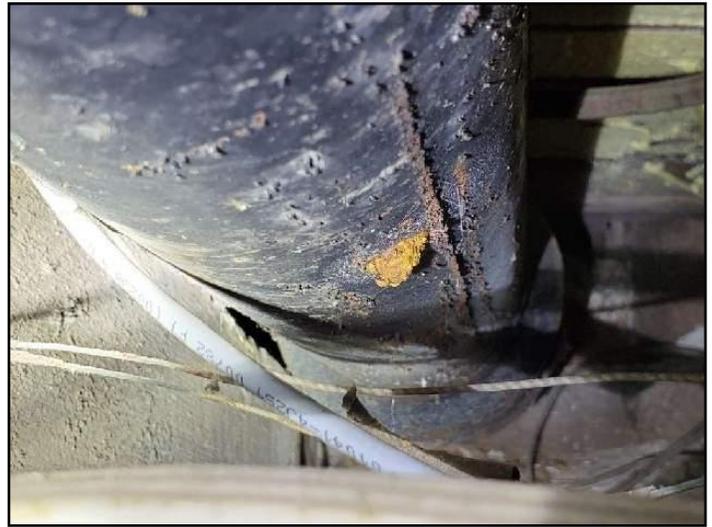
50. Condition: • The cast iron waste pipe in the center of the basement is split and should be replaced.

Location: Center Basement

Task: Replace

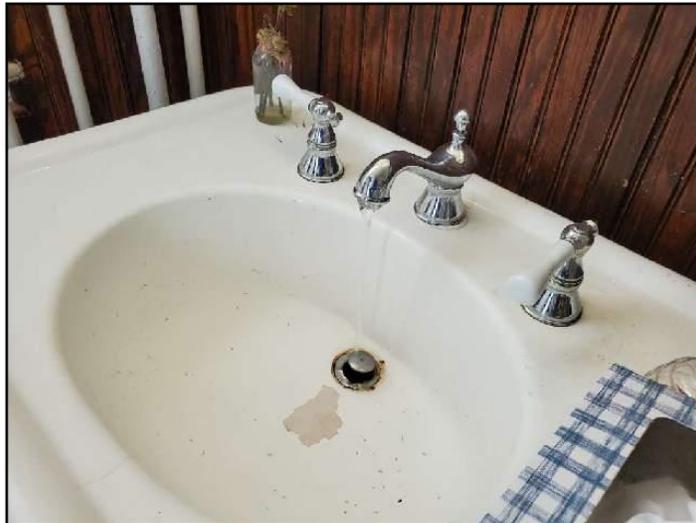
53. Condition: • Low flow was noted at a fixture indicating a possible problem with the valve, the fixture, or associated

pipng. I recommend having this repaired by a licensed plumber.

Location: First Floor Bathroom Sink Cold Water

Task: Repair

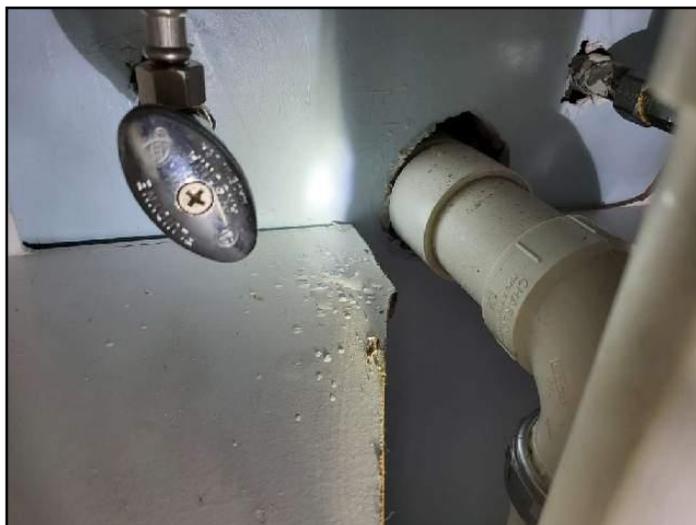
54. Condition: • A faucet is leaking. This leak should be corrected or the faucet replaced.

Location: Left Sink Left Primary Bathroom

Task: Repair or Replace

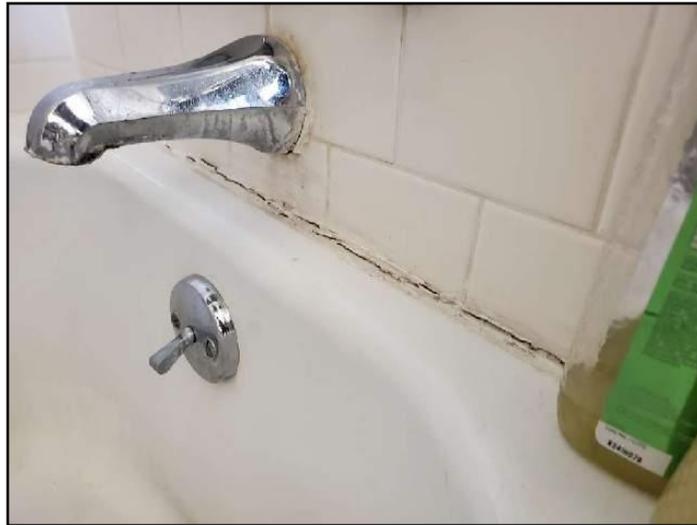
55. Condition: • The tub and/or enclosure should be re-grouted and/or caulked where needed. It is important to keep the grout and caulk in good condition to prevent water infiltration behind the fixtures or surround.

Location: First Floor Bathroom

Task: Improve

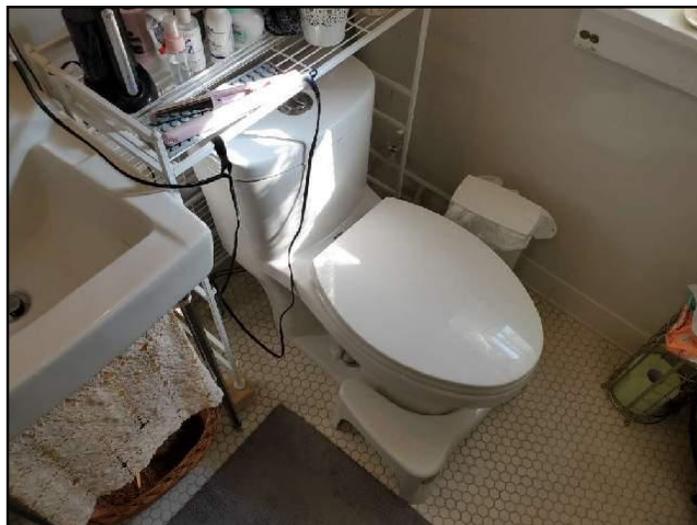
56. Condition: • The toilet is loose. It is possible that the toilet can simply be secured. However, a loose toilet can result in a distorted wax ring. For that reason, I recommend removing the toilet, checking for and repairing any damaged wood subfloor (if the toilet is not on concrete) resulting from leakage, replacing the wax ring and resealing the toilet.

Task: Repair or Replace

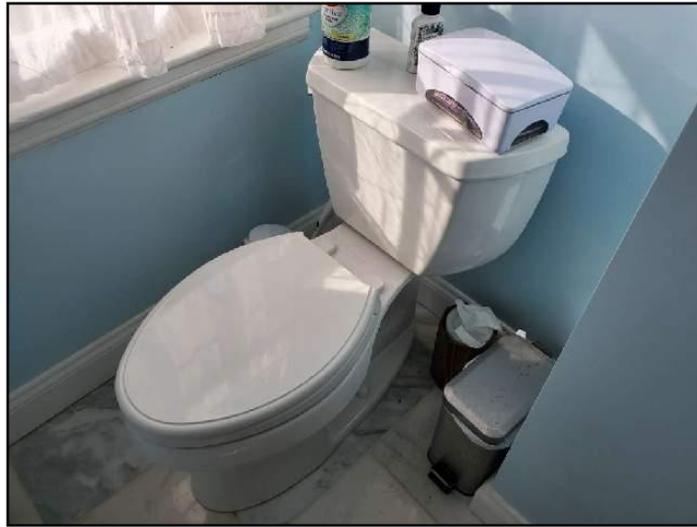
57. Condition: • The toilet runs on after flushing. I recommend replacement or adjustment of the flush valve assembly to eliminate the leakage.

Location: Left Primary Bathroom

Task: Repair or Replace

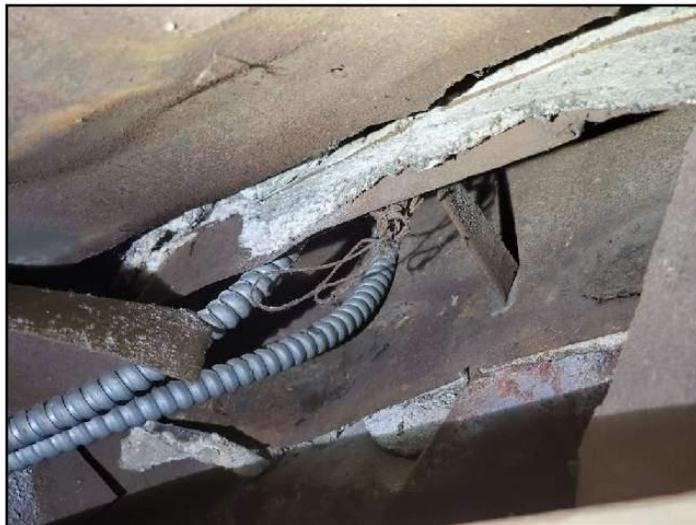
59. Condition: • Asbestos insulation: Insulation on the old metal duct above the center basement beam may contain asbestos. The Environmental Protection Agency (E.P.A.) reports that asbestos represents a health hazard if friable (damaged, crumbling, or in any state that allows the release of fibers). If removal of the asbestos is performed, an asbestos removal specialist should be engaged. If any sections of this insulation are indeed friable, or become friable over time, a specialist should also be engaged. Further guidance is available from the Environmental Protection Agency (E.P.A.). There may be other materials within the home that contain asbestos but are not identified by this inspection report.

Task: Further Evaluation

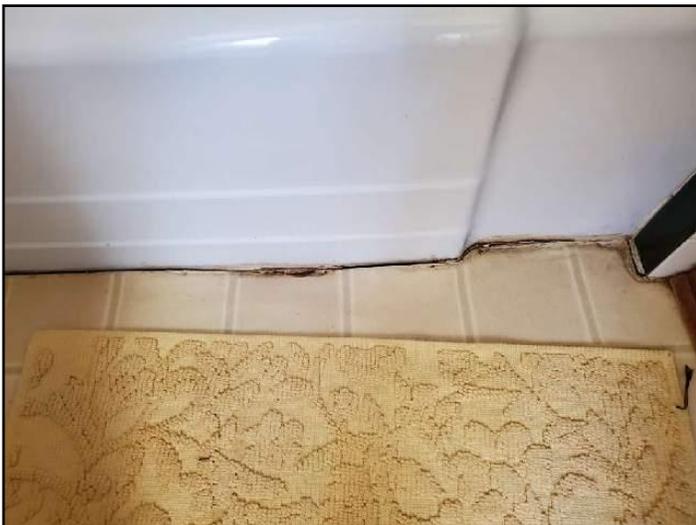
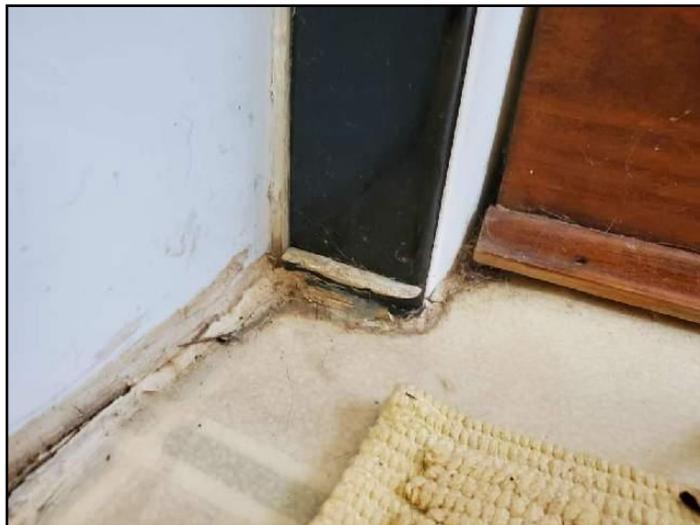
60. Condition: • Evidence of water damage to the floor was observed. Further evaluation will be needed to determine the extent of damage and scope of any needed repair.

Location: First Floor Bathroom at Bathtub

Task: Further Evaluation/Repair

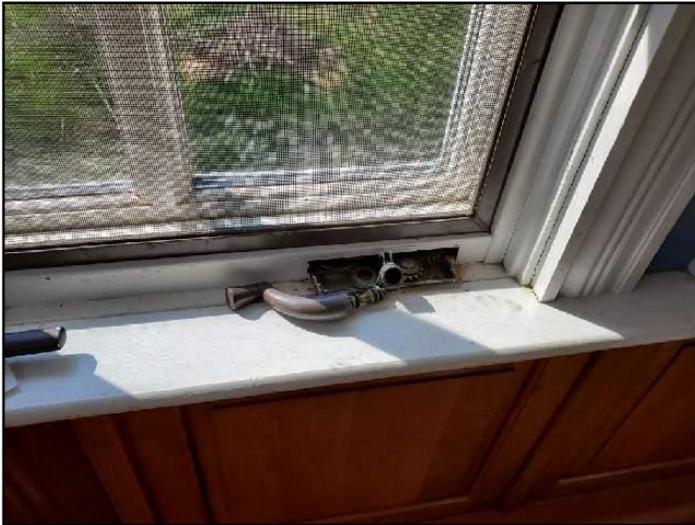
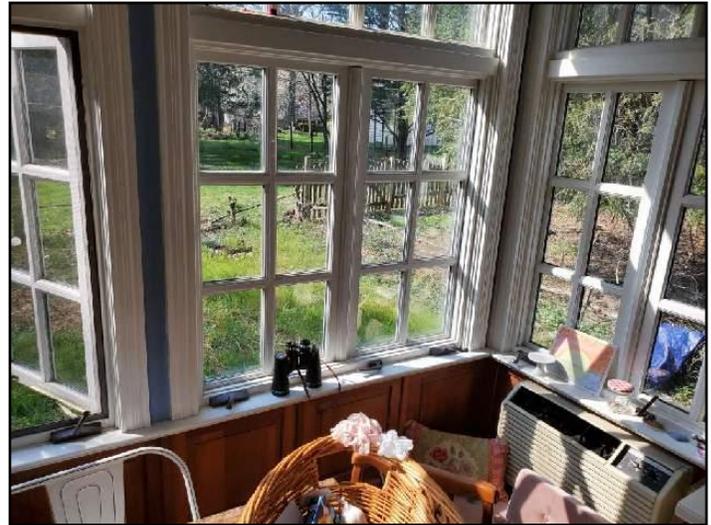
62. Condition: • Hardware (e.g. sash cord, sash spring, lock, tilt latch, etc.) for a window is damaged, broken or missing.

As a result the window does not work properly. I recommend repairing or replacing the hardware, so that the window shuts, opens, locks and seals properly.

Location: Rear Kitchen (Several)

Task: Repair or Replace

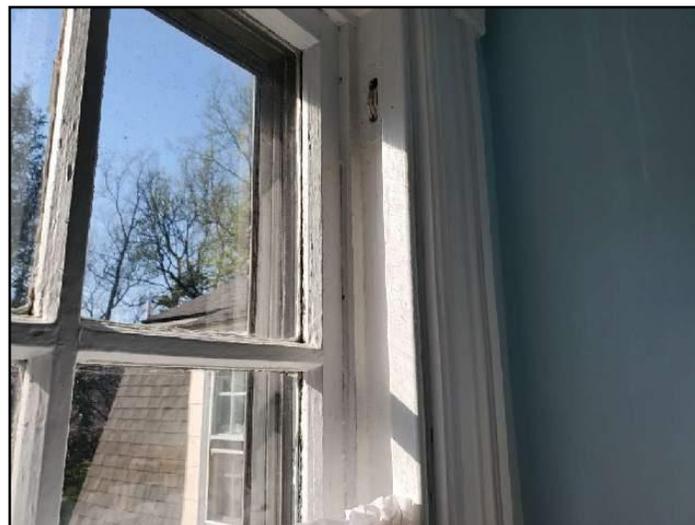
63. Condition: • Hardware (e.g. sash cord, sash spring, lock, tilt latch, etc.) for a window is damaged, broken or missing. As a result the window does not work properly. I recommend repairing or replacing the hardware, so that the window shuts, opens, locks and seals properly.

Location: Left Primary Bathroom Rear Right Window

Task: Repair or Replace

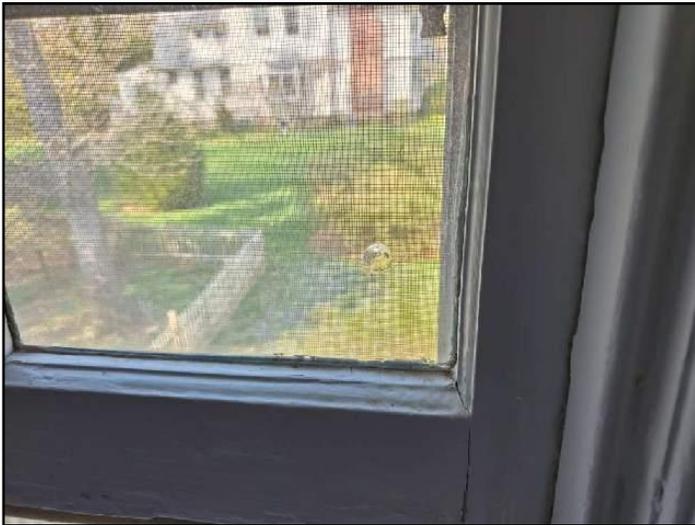
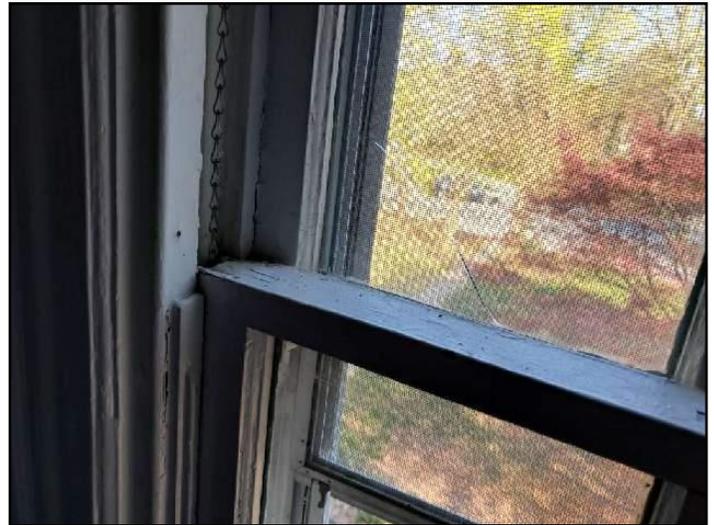
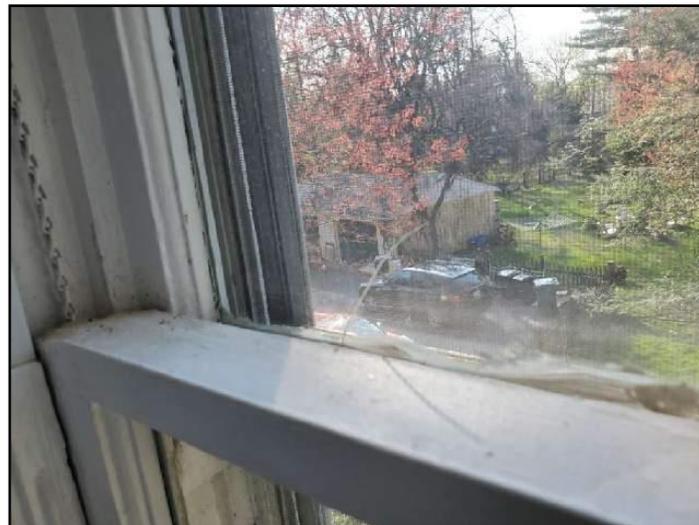
64. Condition: • A window is cracked. I recommend replacement.

Time: Safety Concern

Task: Repair or Replace
