Highland
HOME INSPECTIONS, INC.

INSPECTION DATE:
Thursday, April 8, 2021

RE: Report No. 16256
708 Cliveden Rd W
Baltimore, MD
21208

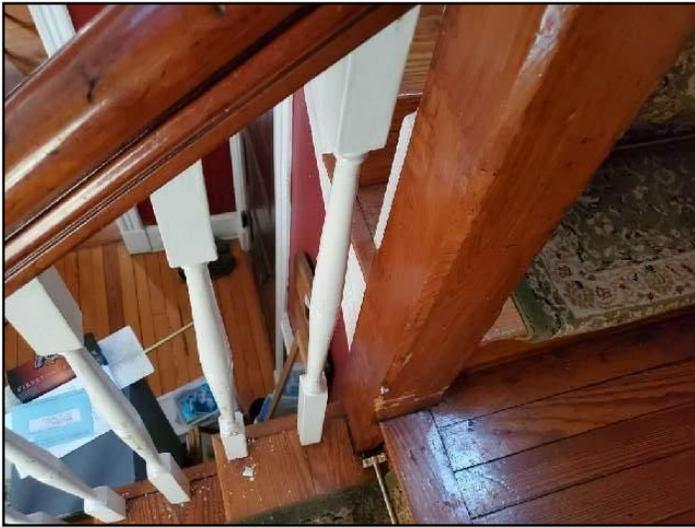
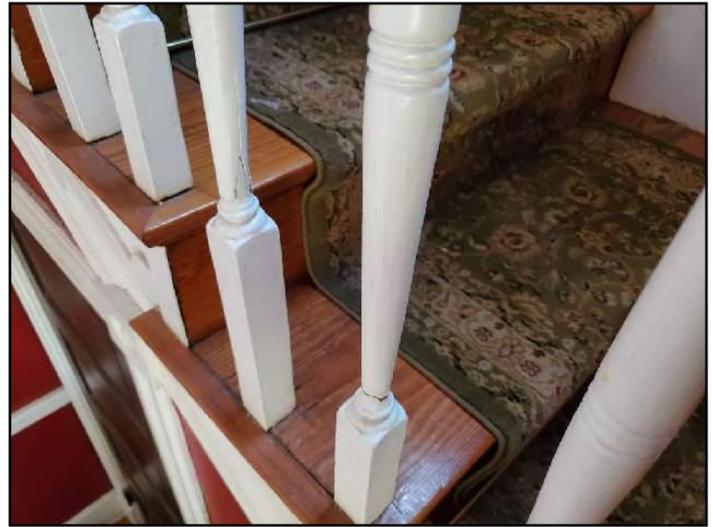
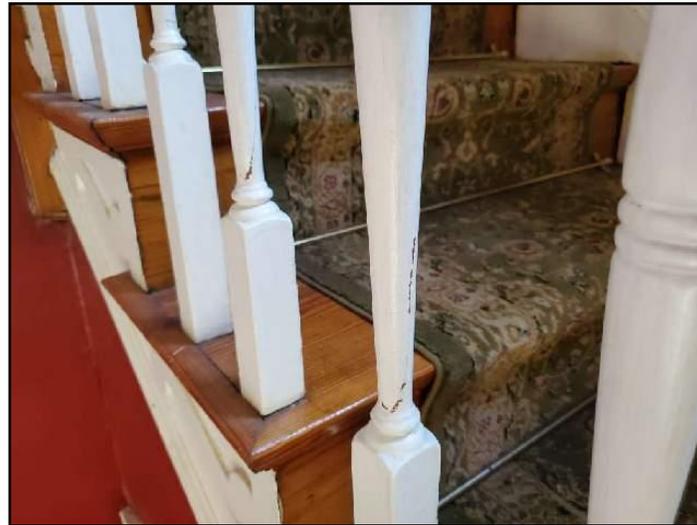
65. Condition: • Several damaged balusters were noted at the second floor stairway railing.

Task: Repair or Replace

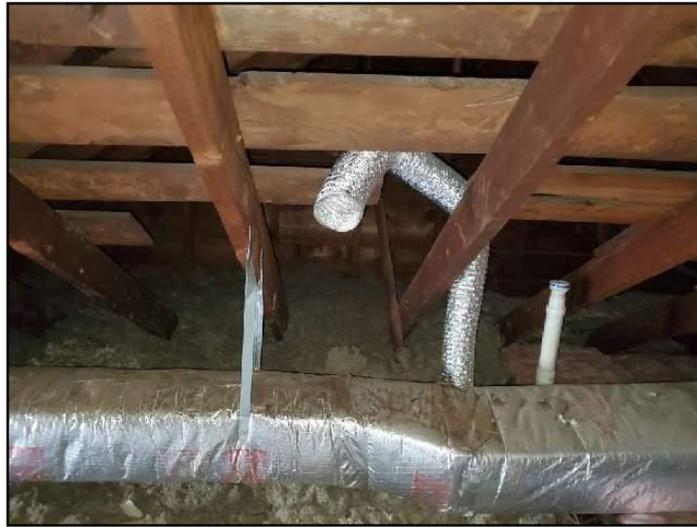
66. Condition: • The exhaust fan discharges into the attic space. This can result in an excessive amount of moisture in the attic which in turn can result in mold growth on the roof sheathing. I recommend extending the discharge up to a ridge vent, gable vent or out to the soffit as necessary to get the air out of the attic.

Task: Repair

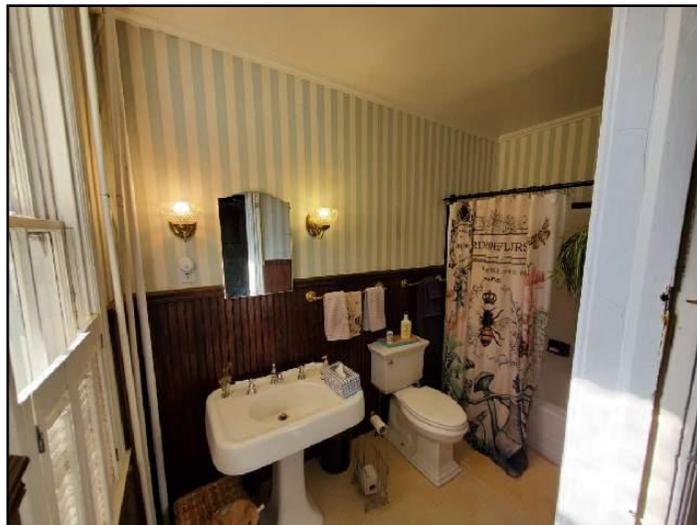
67. Condition: • When this house was built, the window satisfied the venting requirements for the bathroom. However, I recommend considering the installation of an exhaust fan in each of the full bathrooms (where one does not already exist) that discharges to the exterior to reduce the buildup of moisture in the house and attic.

Location: First Floor Bathroom

Task: Improve

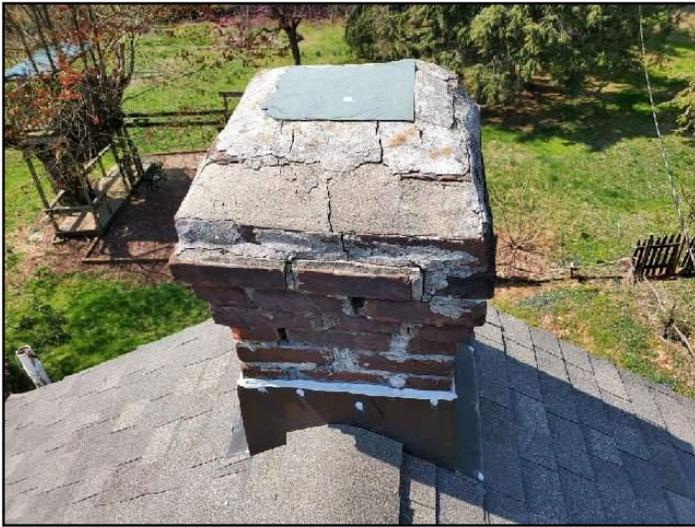
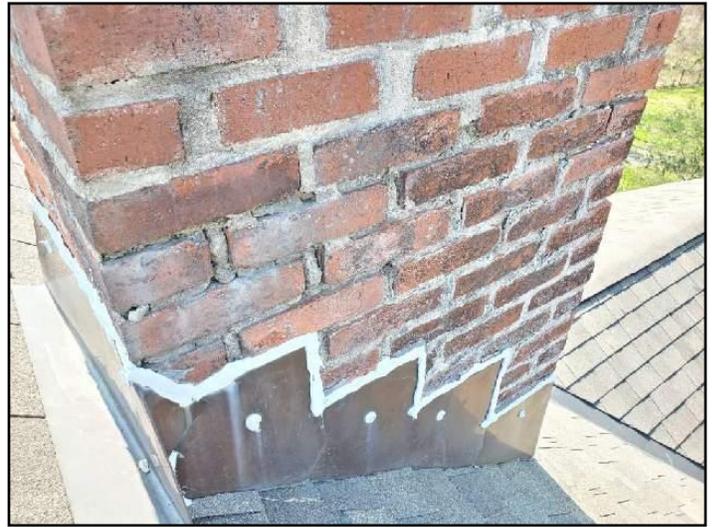
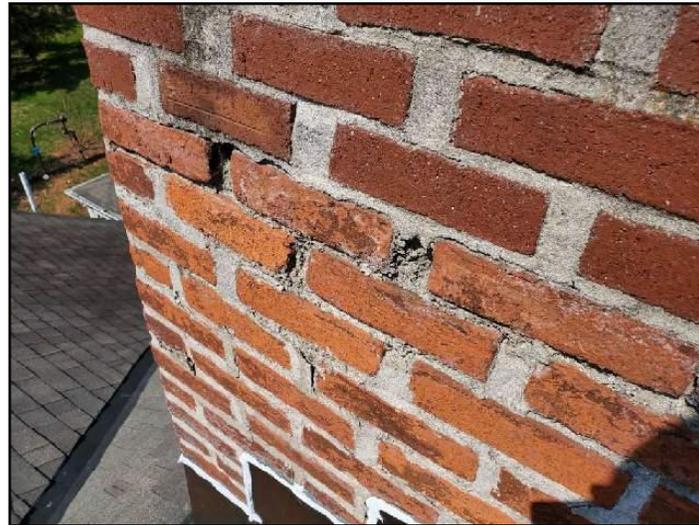
71. Condition: • The masonry chimney needs re-pointing (replacing the mortar between the brick or stone) to avoid water damage. I recommend having the chimney mortar joints repointed. The entire flue should be checked by a qualified chimney sweep in conjunction with repairs.

Task: Repair

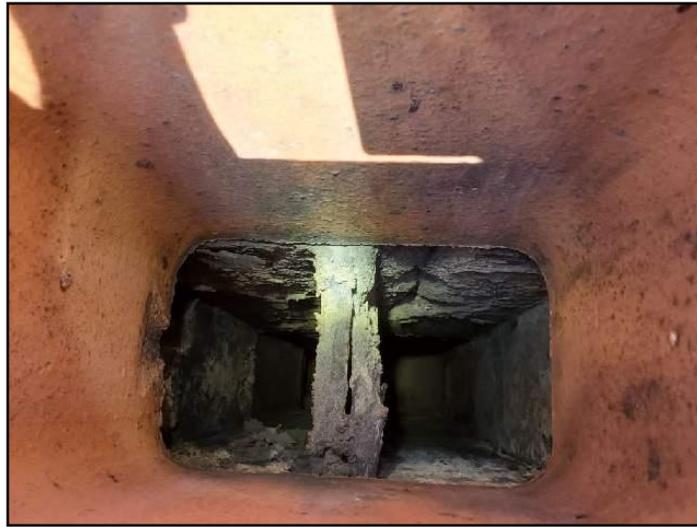
72. Condition: • One or more sections of flue liner for the masonry chimney are cracked. I recommend having the broken section(s) evaluated for replacement. The entire flue should be checked by a qualified chimney sweep in conjunction with repairs.

Location: Water Heater Flue
